# **Smoke and Dye Testing Summary**

## **High Level Sewershed**

Run Summa	iry <del></del>						
Test ID	Test Type	Date Inspected	Company / Super.	Blower MH	Ground Condition	Notification Made?	Total Length
S1028-207	Smoke	7/28/2009	ADS/TM	S17AA_002MH	Dry	Yes	663.79

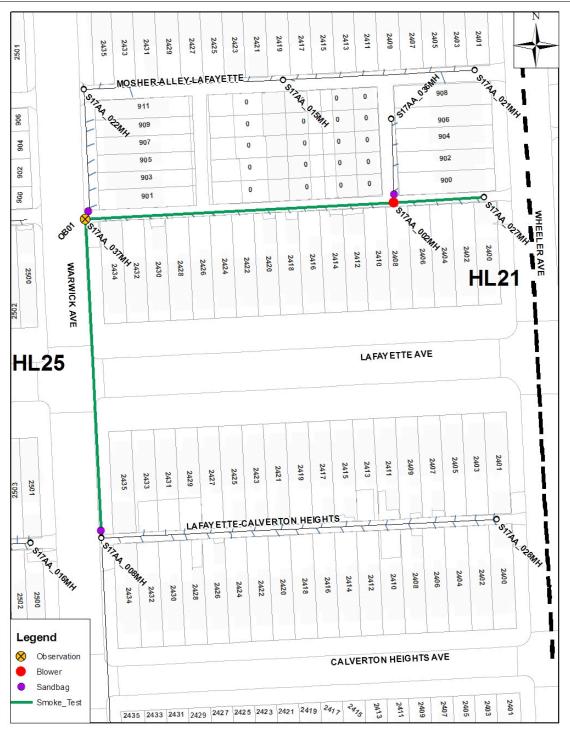
**Picture** \S1028-207-OB01-P01.jpg

**Comments** Smoke from sanitary manhole S17AA\_037MH

in the alley south of 901 Warwick Ave.

**Comments** Warwick Ave. & Alley looking

northwest
